RESULTS OF THE STUDY ON THE EVALUATION OF THE TECHNICAL CONDITION OF HYDRAULIC STRUCTURES OF RESERVOIRS

Ospanova Dilbar Keulimjaevna
Karakalpak State University
Paluanov Daniyar Tanirbergenovich
Tashkent State Technical University

Research results. As an object of research, the Talimarjan water reservoir located in the Nishan District of Kashkadarya region was taken. The district seismicity, where the Talimarjan water reservoir is located, is 7 points, the capital of the building is Class II, the construction was carried out in 1974-1983 years. This reservoir was commissioned for exploitation in 1985 year. The total volume of water ombor-1525 million.m³, useful volume-1400 million rubles.m³, dam type-same-sex, 1-dam height-35 m, 2 – dam height – 36 m, water discharge plant type-2 – tower, water permeability in the central part of the dam-360 m³/s (Figure 1).

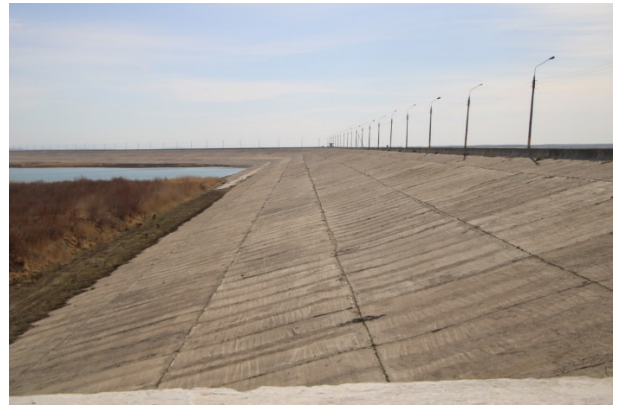
b) upstream slope position

1. The top of Dam-1 is in satisfactory condition. Deformations were detected in the slabs P23 – P60 (P – Picket) at the mark 390.0 m on the slabs supporting the berm. There are also deformations in the slope plates attached to the berm. Some of the reinforced concrete slabs in the dam cladding are in a slippery condition and the deformation seams are exposed. At the 390.0 m mark, there is a filtration rate of 6-8 m/s to the collector through a reinforced concrete pipe that carries the sediment. Sand is collected in the pipe under the influence of wind, which may have passed through the water intake well from the rainwater drainage system. The water intake pipe is not protected by a reverse filter from the soil spilled on it. In P46-70 in the collector, water leaked from the slope, as a result of which the slope soil flowed into the collector and created turbid pressure.
